Manhole Inspection Summary

Manhole # S05YY_020MH

Insp Date: **7/16/07 10:07 AM**

Location Address: **3809 DORCHESTER AVE** Cross Street: **GARRISON BLVD**

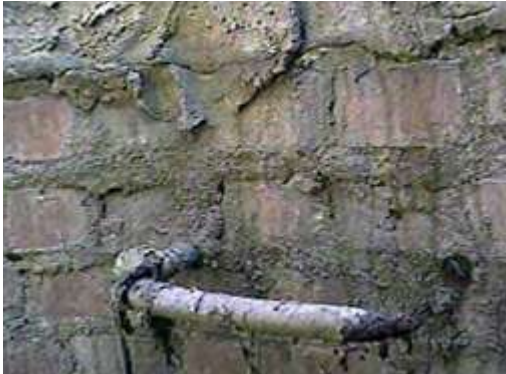
Defect 1

Steps Count: **5** Missing: **0** ☒ **Corroded**

Surcharge ☒ **Evidence Of Surcharge** Depth: **2** (ft.) ☐ Active Surcharge Present

CORRODED RUNG AND EVIDENCE SURCHARGE

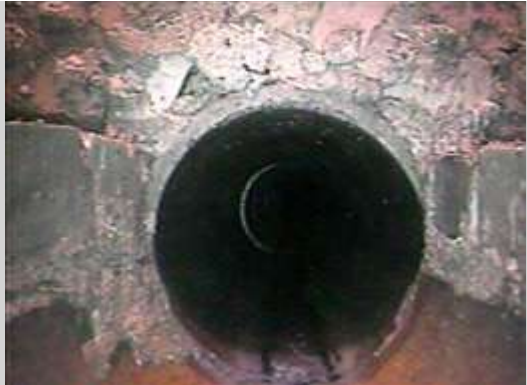
12 O'Clock Outflow

8 in. Circular Gravity Sewer
Pipe Out @ 12 O'Clock

Pipe Height: (in.) Direct
Pipe Material: **Clay** ☐ Pipe Lined
Invert Depth: **9.92** (ft.) Flow Characteristics: **Slow**
Deposits: ☒ None ☐ Mud ☐ Sludge ☐ Debris ☐ Grease
Silt Depth: (in.) Deposits Extent:
Infiltration: **None** Pipe Seal Cond: **Sound**

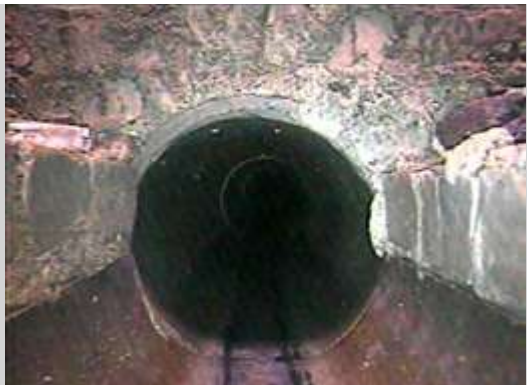
6 O'Clock Inflow

8 in. Circular Gravity Sewer
Pipe In @ 6 O'Clock

Pipe Height: (in.) Direct
Pipe Material: **Clay** ☐ Pipe Lined
Invert Depth: **9.82** (ft.) Flow Characteristics: **Slow**
Deposits: ☒ None ☐ Mud ☐ Sludge ☐ Debris ☐ Grease
Silt Depth: (in.) Deposits Extent:
Infiltration: **None** Pipe Seal Cond: **Sound**
